CONDITION SURVEY SUMMARY

SANDERSTEAD LIBRARY Farm Fields, Sanderstead. CR2 0HL

Sanderstead Library Condition Survey

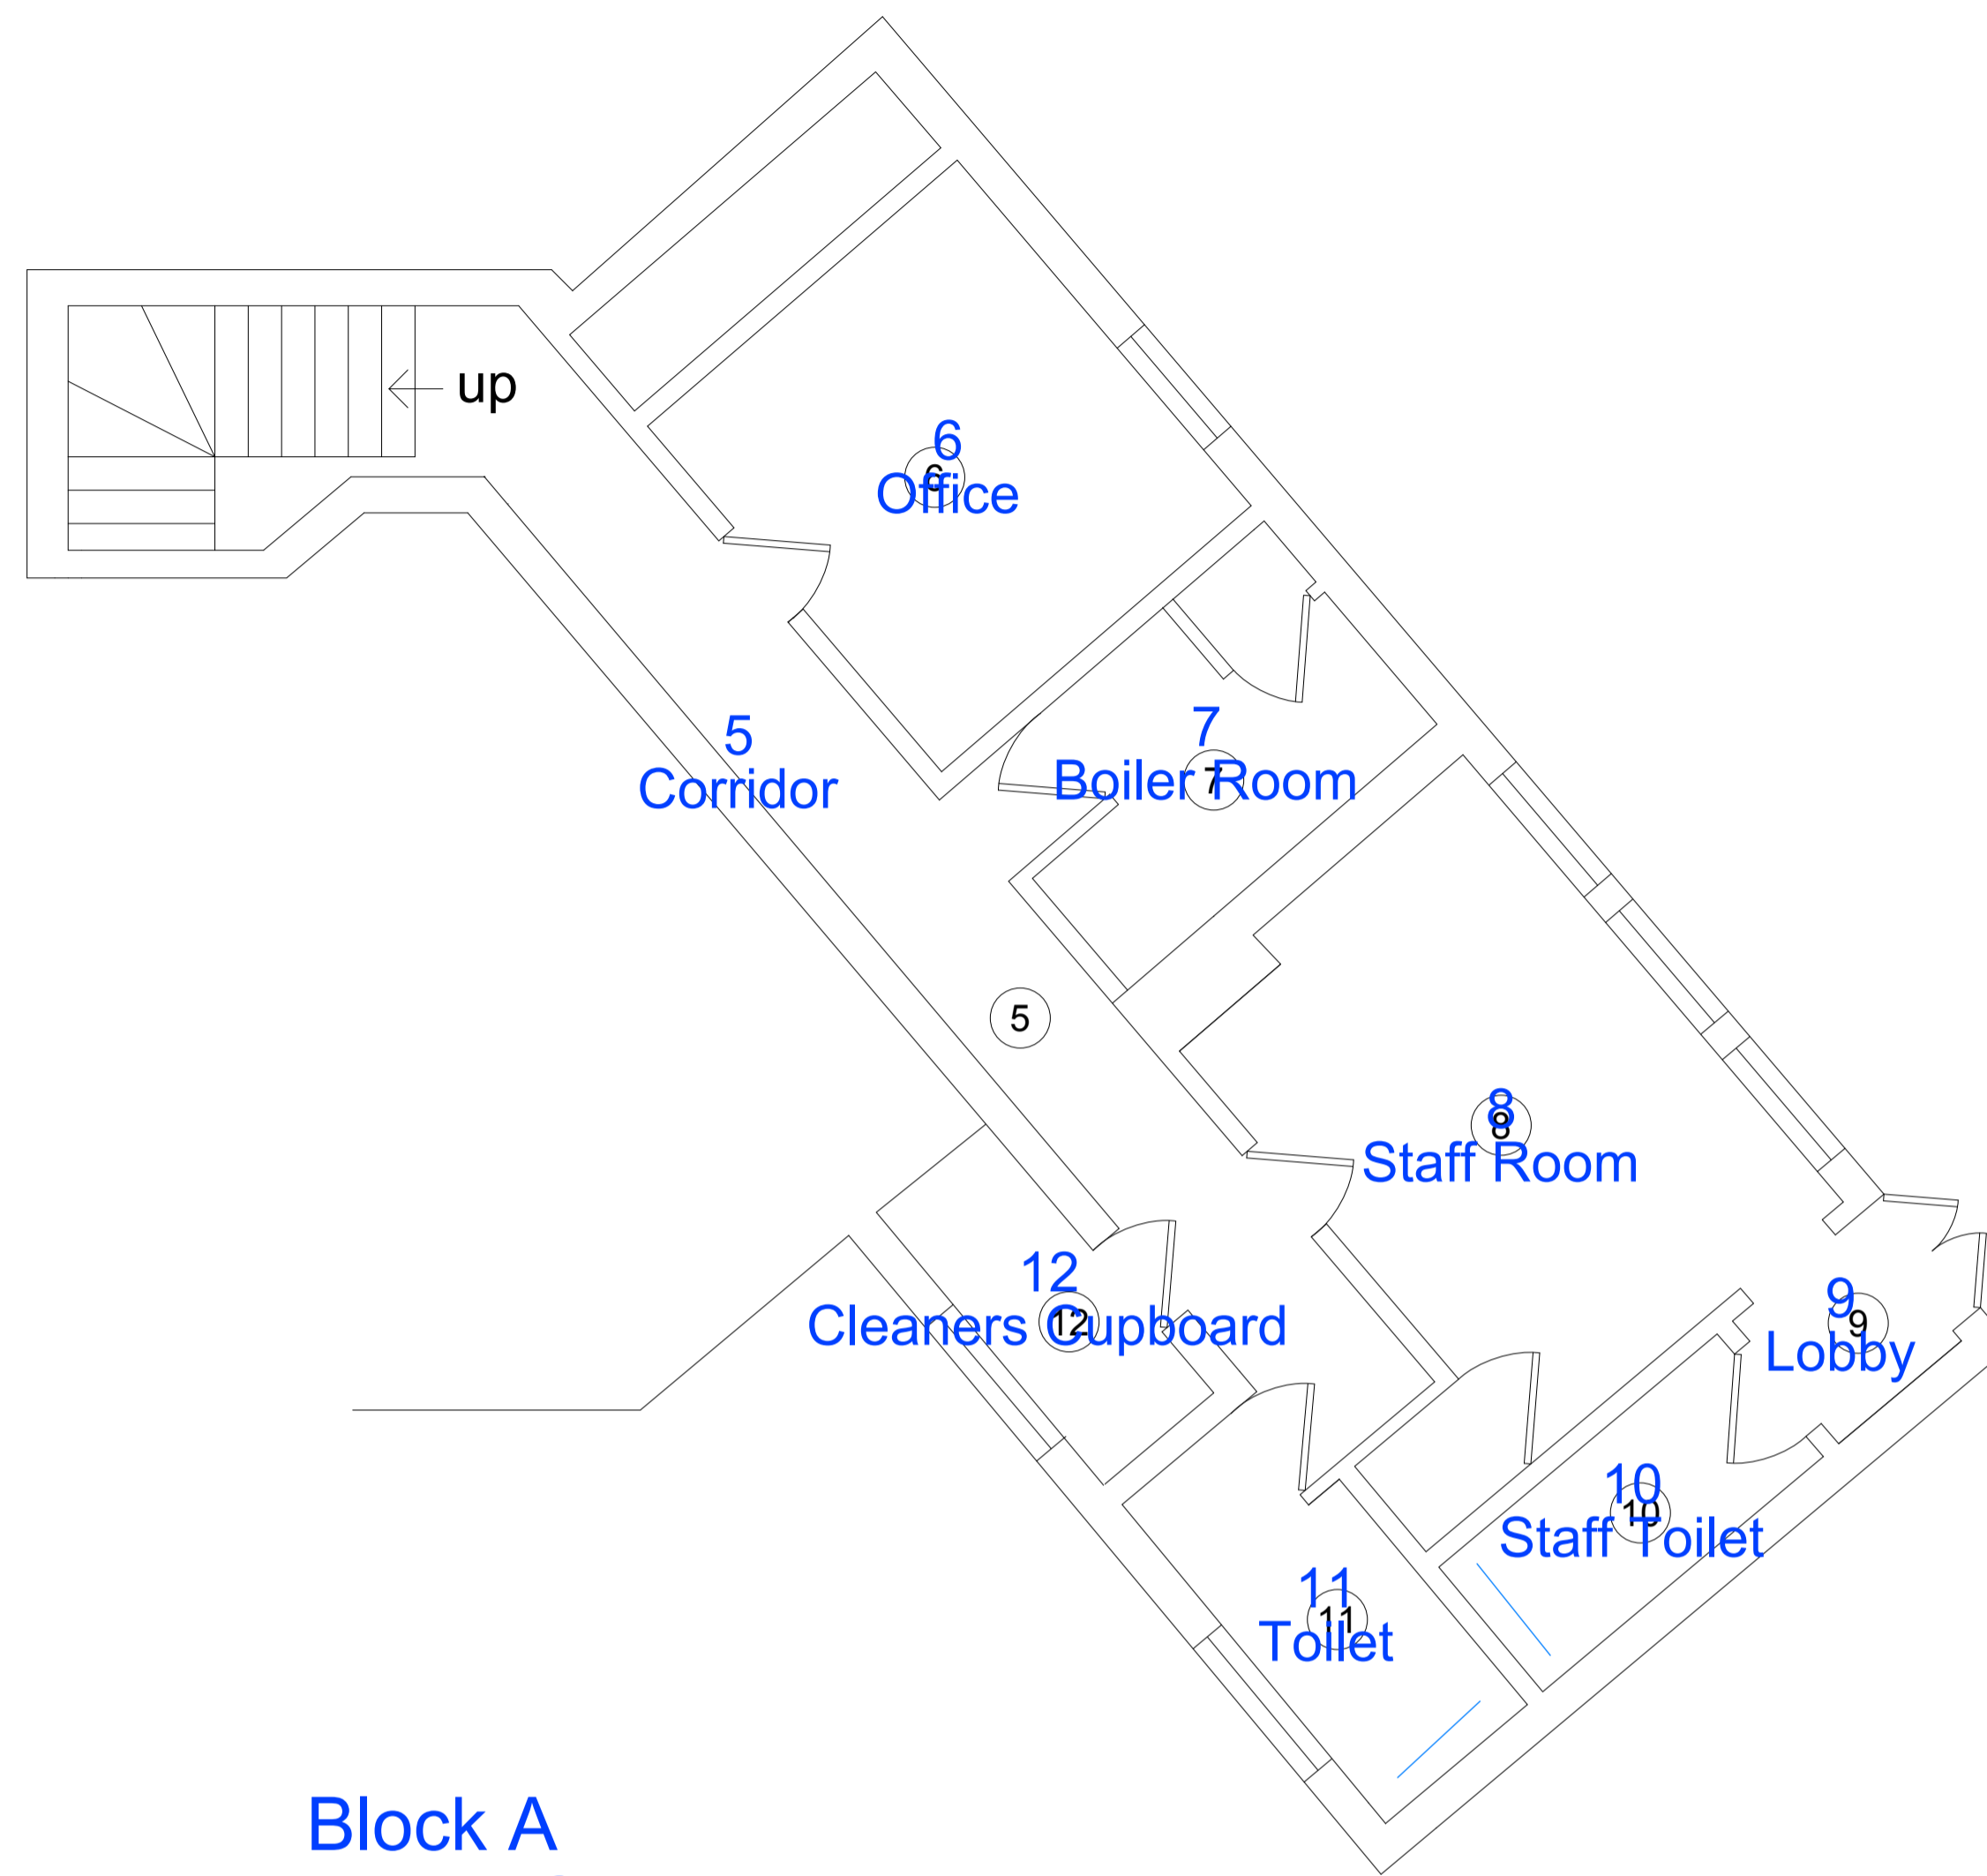
Lower Ground Floor
Block A

Key Locations:

- 5 Corridor
- 6 Office
- 7 Boiler Room
- 8 Staff Room
- 9 Lobby
- 10 Staff Toilet
- 11 Toilet
- 12 Cleaner's Cupboard

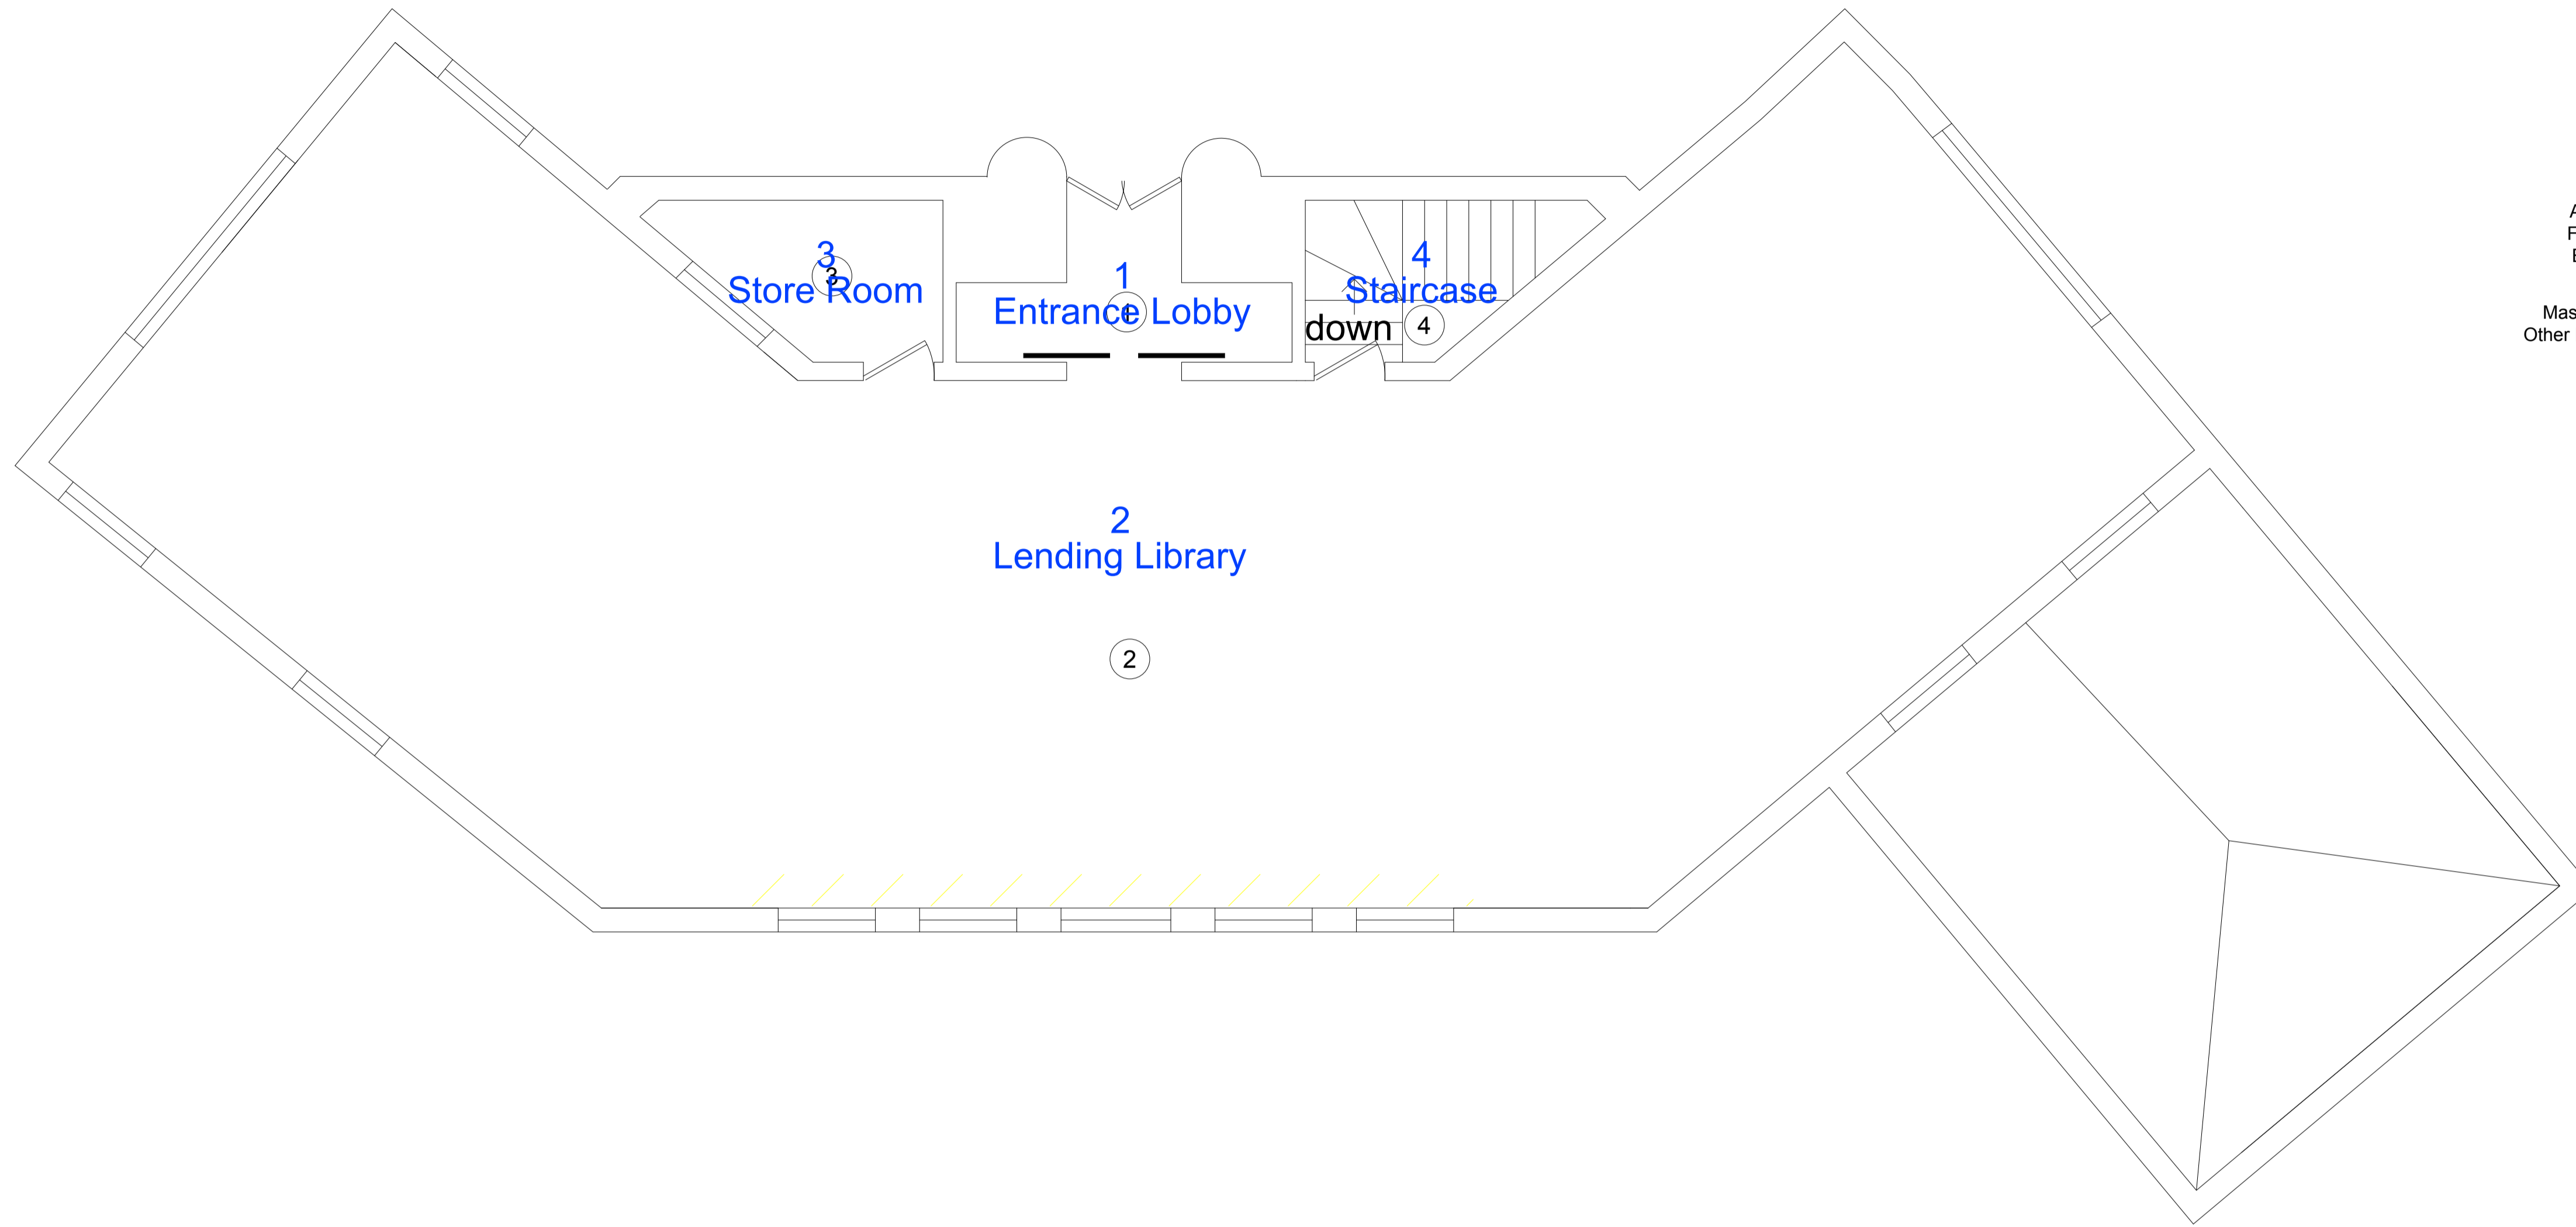
Block A
Ground Floor

Site Area:
 Gross External Area: 294.2
 Gross Internal Area: 260.1
 Total Room Area: 215.6
 Net Internal Area: 171.7
